Arizona Geology

Vol. 36, No. 3
FALL 2006

Recent Debris Flows and Floods in Southern Arizona

Philip A. Pearthree and Ann Youberg

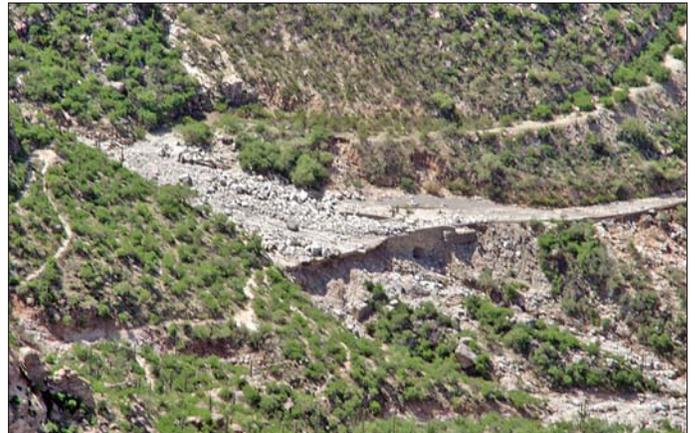
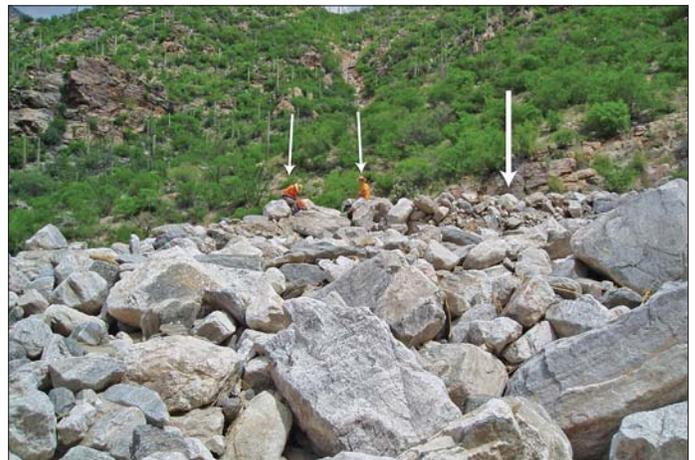
Figure 1. Aerial and ground photos of debris flow deposits burying the end of the tram road in Sabino Canyon. The tram road turnaround is beneath the boulder pile in the ground view; note Lee Allison and Todd Shipman of the AZGS for scale. Large white arrow points to the location of buried rest room facilities. Aerial photo provided by R.H. Webb.

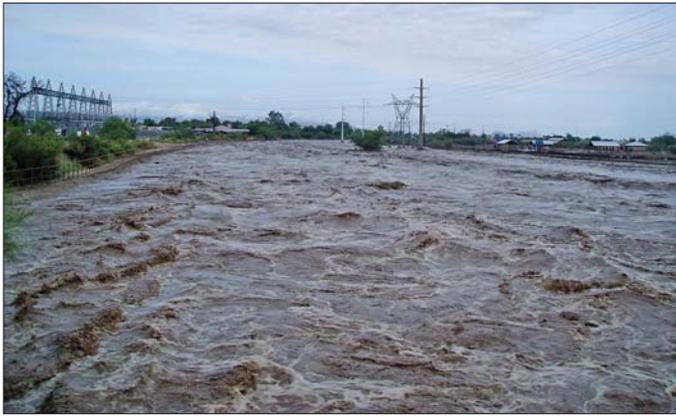
Figure 3. Photo of Rillito Creek looking downstream from the Dodge Boulevard bridge in Tucson during the morning of July 31, 2006. Photo by Todd Shipman.

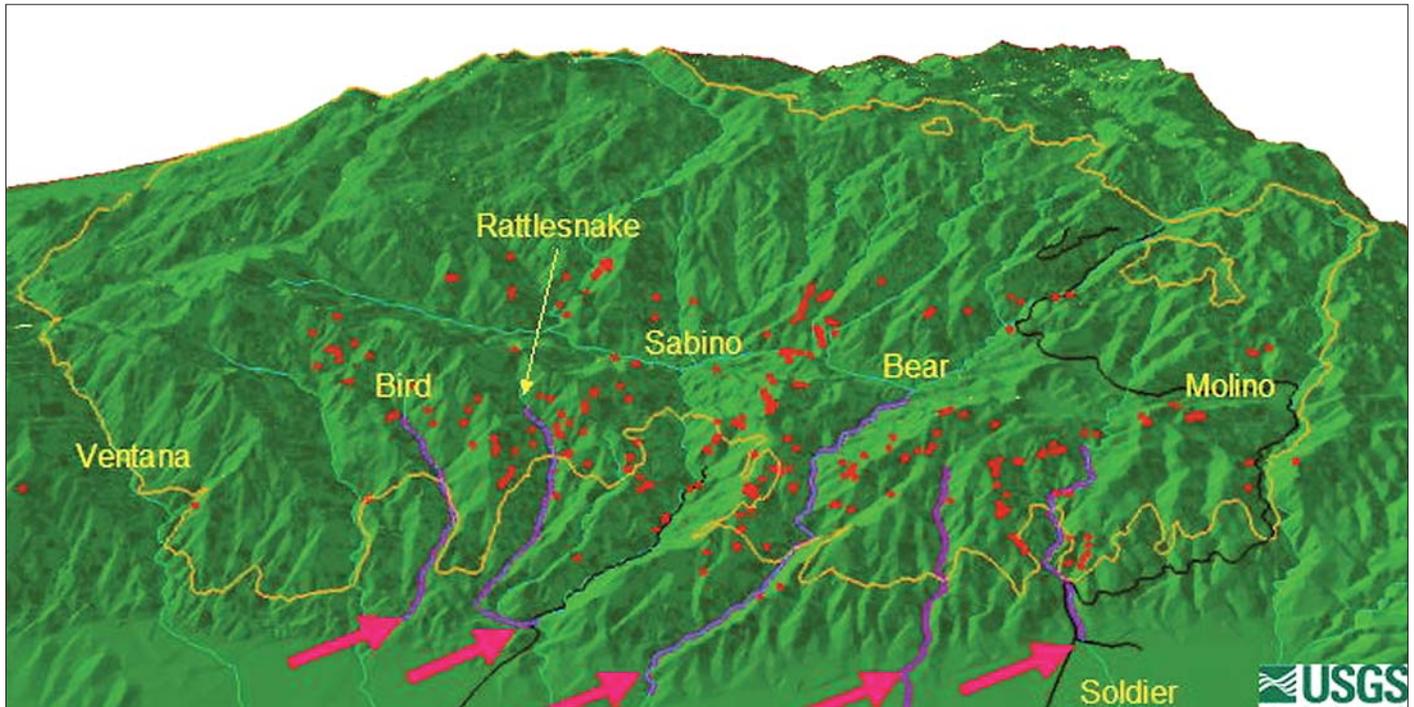
Figure 4. Map showing locations of debris flow initiation in the Santa Catalina Mountains. Large debris flows that occurred in several canyons are shown with purple lines and pink arrows (modified from Magirl et al, 2006).

The most spectacular debris flows occurred in the southern Santa Catalina Mountains just north of Tucson, an area that includes the Sabino Canyon Recreation Area managed by the U.S. Forest Service. At least 250 separate debris flows initiated on steep mountain slopes in a swath extending from Ventana Canyon on the west to the Mt. Lemmon Highway on the east (Figure 4) (Chris Magirl and Peter Griffiths, U.S. Geological Survey, oral communication). Most of the debris flows began as discrete

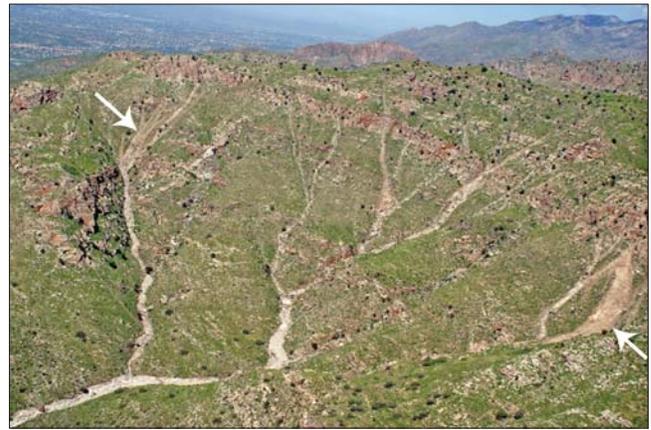
Figure 5. Hillslope failures of various sizes developed into debris flows in Soldier Canyon. Most failures initiated in small channels on hillslopes, but arrows point to large areas of hillslope colluvium failure. Photo provided by R.H. Webb.

failures of thin hillslope or gully deposits over bedrock, but in a few areas broad swaths of hillslope failed (Figure 5). Many fresh scars on mountainsides left by the debris flows (nearly vertical light-colored stripes) are quite evident from the central and eastern Tucson metropolitan area. Individual flows entrained more sediment as they proceeded downhill, and in some cases merged and developed into large debris flows that continued several miles down the canyons. Debris flows deposited large piles of medium to large boulders where debris flows spread out or stopped; much of the finer-grained sediment in the slurries was washed downstream.

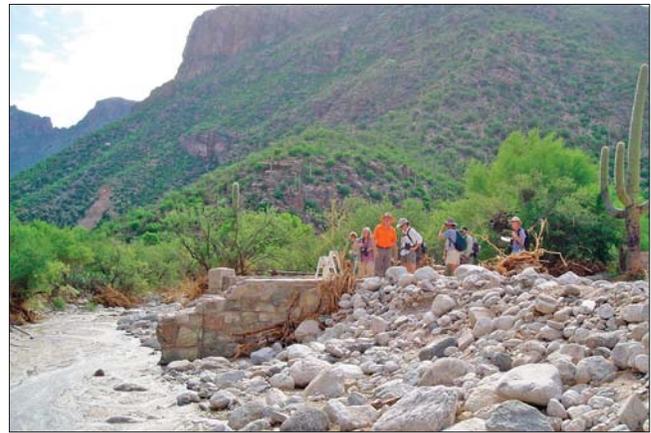
Figure 6. A large debris flow that came down Rattlesnake Canyon into Sabino Creek completely blocked the Rattlesnake Creek Bridge with coarse sediment and eroded the northern approach of the tram road. The people are standing on the bridge; Sabino Creek is behind them.

In Sabino Canyon, the tram road that provides access to much of the canyon was damaged in many places. A large debris flow came down Rattlesnake Creek, completely clogged the bridge across this creek and eroded the approach to the bridge (Figure 6). Sediment deposition

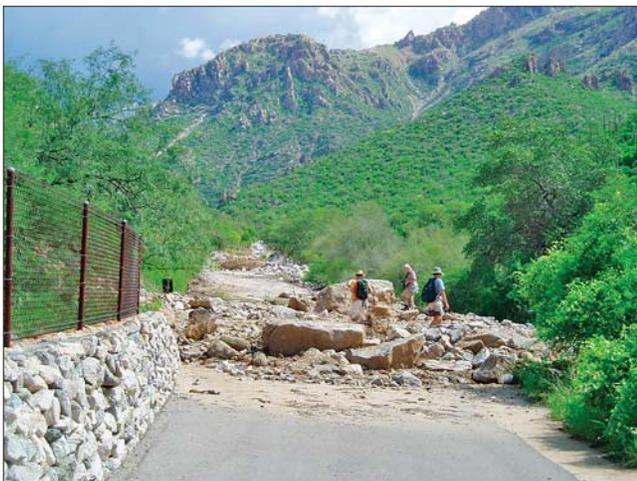
Figure 7. Pile of boulders left on the Sabino Canyon tram road by a medium-sized debris flow. Notice that the debris flow avoided the rock and wire fence built to catch rockfall debris.

immediately downstream raised the bed of Sabino Creek by about 20 feet (Robert Webb, U.S. Geological Survey, oral communication). Farther into Sabino Canyon, boulder deposits blocked the road in at least six places (Figure 7). Between tram stops 7 and 8, an ~500 ft long stretch of road was damaged and covered with sediment, and numerous large boulders were deposited in Sabino Creek (Figure 8). The end of the tram road was completely buried by boulders and restroom facilities were destroyed (Figure 1). Fortunately, no people were killed or injured because the debris flows and flooding occurred in the early morning hours. The U.S. Forest Service has partially reopened the tram road but is still considering whether it is advisable to attempt to repair the remainder of the road.

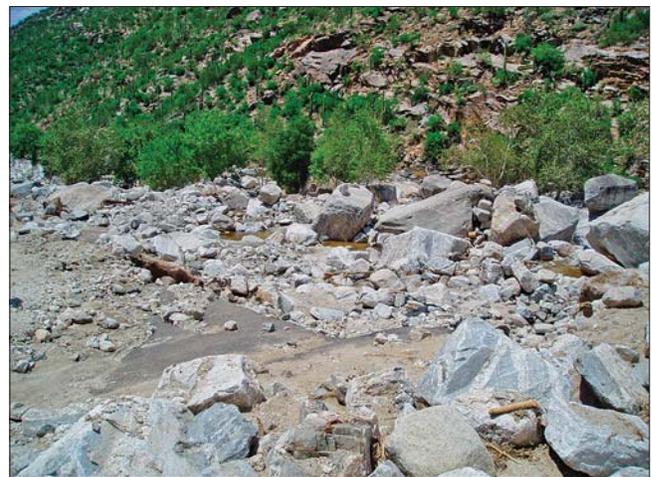
Figure 8. Boulders and other debris dumped into Sabino Creek by a large debris flow near tram stop 8. The tram road is mostly buried by debris flow deposits in the foreground.

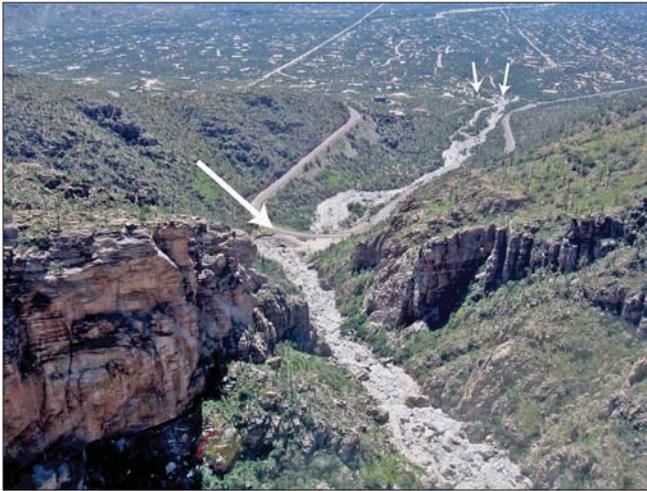
Figure 9. A debris flow in Soldier Canyon passed through large culverts beneath Mt. Lemmon Highway (large arrow) and deposited cobbles and boulders just upstream from several homes (smaller arrows in middle distance). Photo provided by Chris Magirl.

Debris flows actually reached the mountain front in several canyons adjacent to Sabino Canyon. At Soldier Canyon it appears that a debris flow passed through large culverts beneath Mt. Lemmon Highway and flowed about 0.5 miles farther downslope (Figure 9). A substantial amount of coarse sediment was deposited near the canyon mouth downstream of the highway, stopping just short of several houses. Flooding and sediment run-out from the debris flow did impact these houses, and water flooding spread into areas that had not been impacted by large floods in 1983 and 1993.

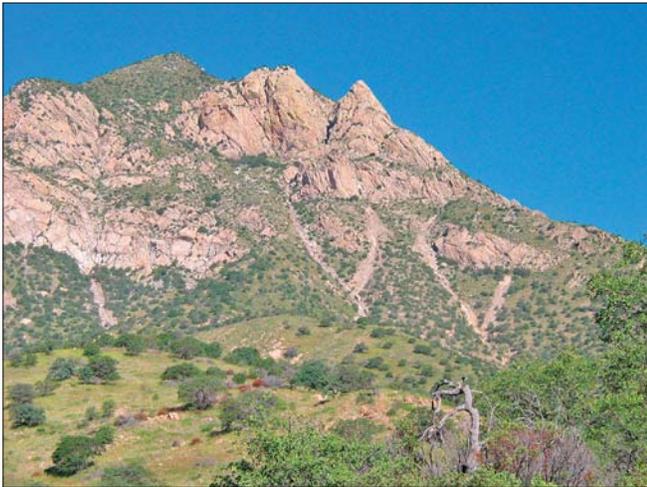
Figure 10. Debris flow scars on the flanks of Montezuma Peak, Coronado National Memorial.

Coronado National Memorial and adjacent areas in the southern Huachuca Mountains were also hard-hit. More than 60 debris flows occurred in this area (Figure 10), burying National Park Service facilities and destroying the main gravel road that traverses the park along the U.S. - Mexico border (Figure 11) (Youberg et al, 2006). After four months of repairing the park, Coronado National Memorial is once again open to the public.

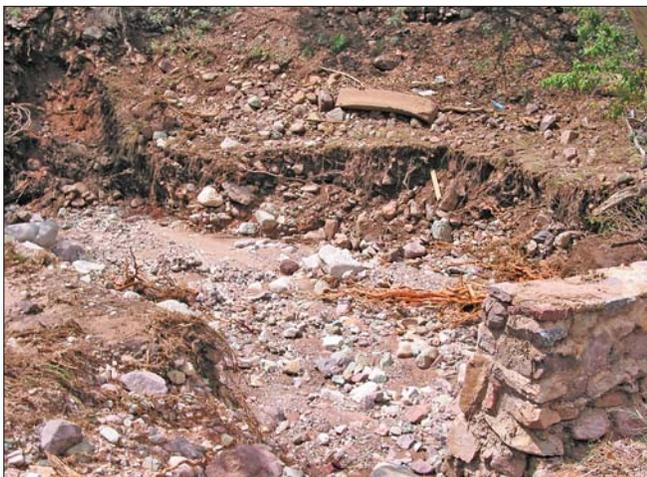
Figure 11. Downstream view of flood damage on Montezuma Creek near the Coronado National Memorial Visitors Center.
